**Alberta Conservation Association  
2008/09 Project Summary Report**

**Project name:** *A Preliminary Investigation of Crossings Structures in the Driftwood River Drainage Basin, Slave Lake, AB*

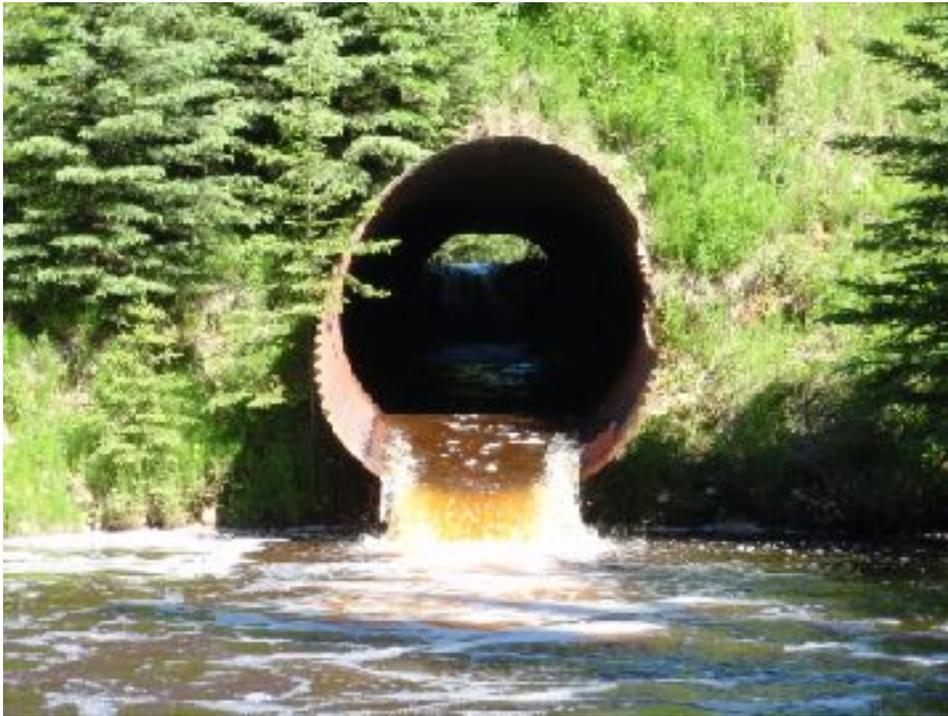
A hanging culvert on a tributary to the Driftwood River. (Photo: Chad Lyttle)
