**Comparison of 2009 and 2021
Riparian Health Assessments
in the Beaverlodge River Watershed of
Alberta Using Aerial Videography**

**ACA PROJECT
REPORT**

Taylor Lund
Alberta Conservation Association
#101, 9 Chippewa Road
Sherwood Park, Alberta, Canada T8A 6J7

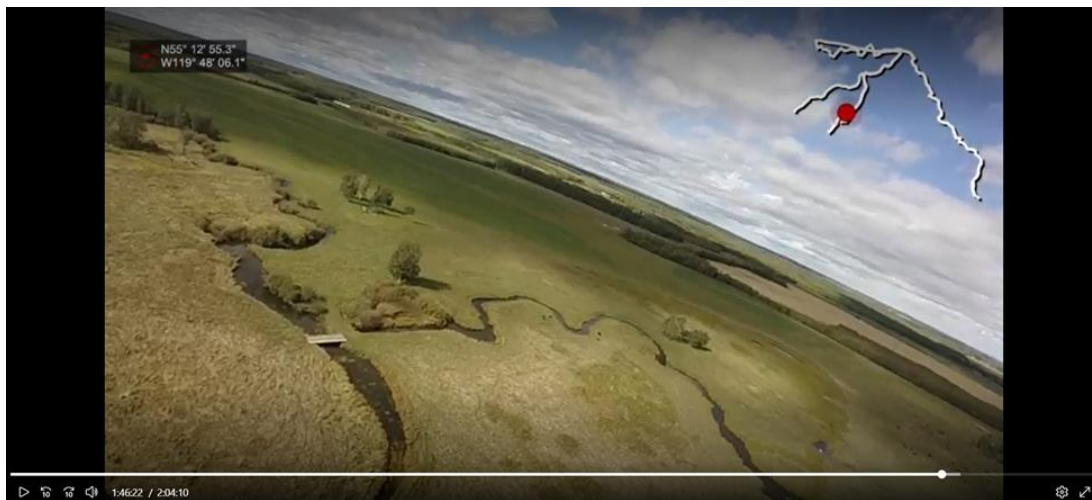
Figure 7. Windsor Creek near the confluence with Beavertail Creek (Appendix 2g) received Poor health scores with active livestock grazing on both streambanks.

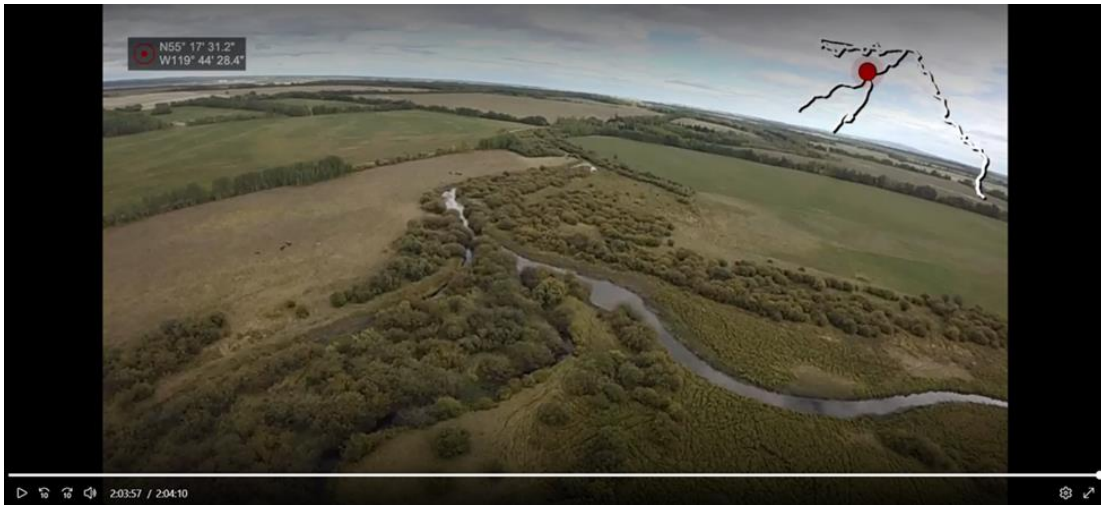
Figure 8. Steeprock Creek near the confluence with Beavertail Creek (Appendix 2h) received Poor health scores with active livestock grazing on both streambanks.

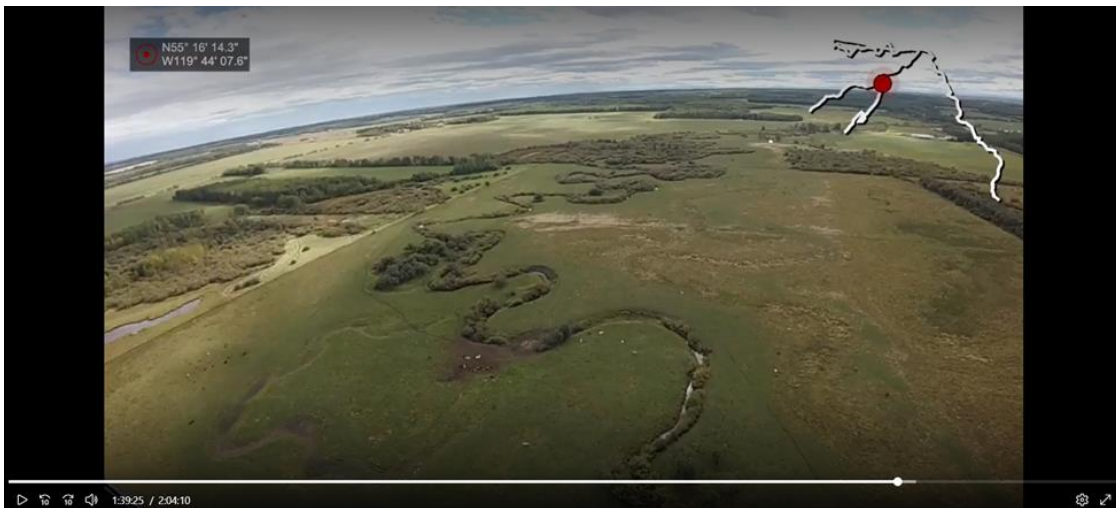
Figure 9. Beavertail Creek received Poor health scores directly north and south of Highway 671 (Appendix 2e and 2f) due to heavily grazed pasture and bare ground.

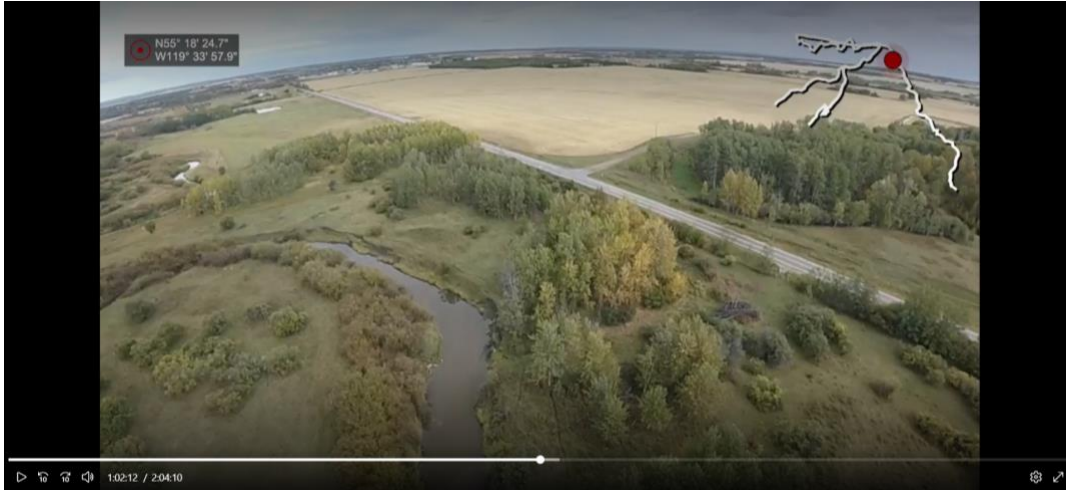
Figure 10. Beaverlodge River received Poor health scores near the town of Hythe (Appendix 2c) due to slumping banks and lack of woody vegetation.

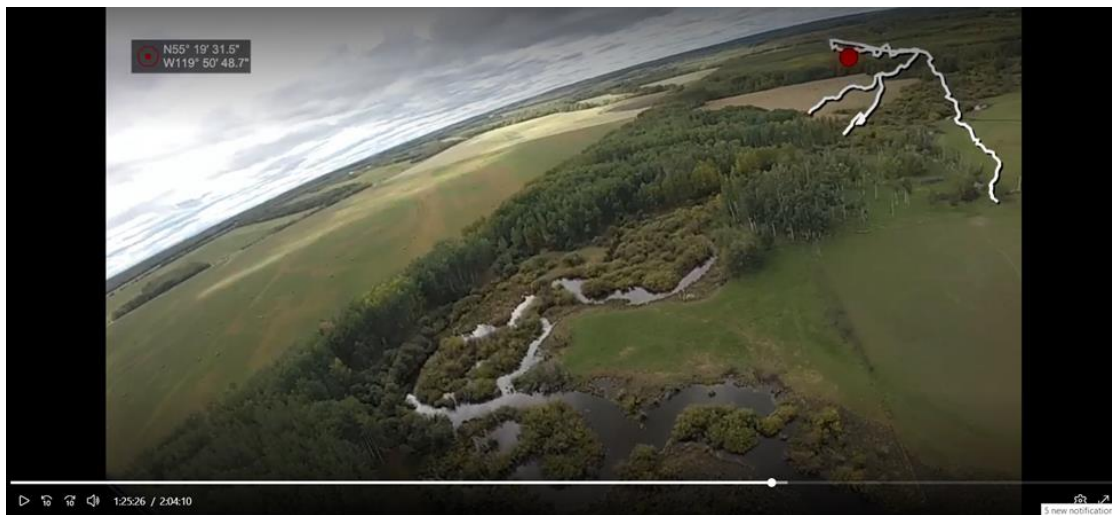
Figure 11. Beaverlodge River received Poor health scores west of Horse Lake (Appendix 2d) due to heavily grazed pasture and bare ground.
