**Alberta Conservation Association
2009/10 Project Summary Report**

Project Name: *Beaverlodge Riparian Conservation*

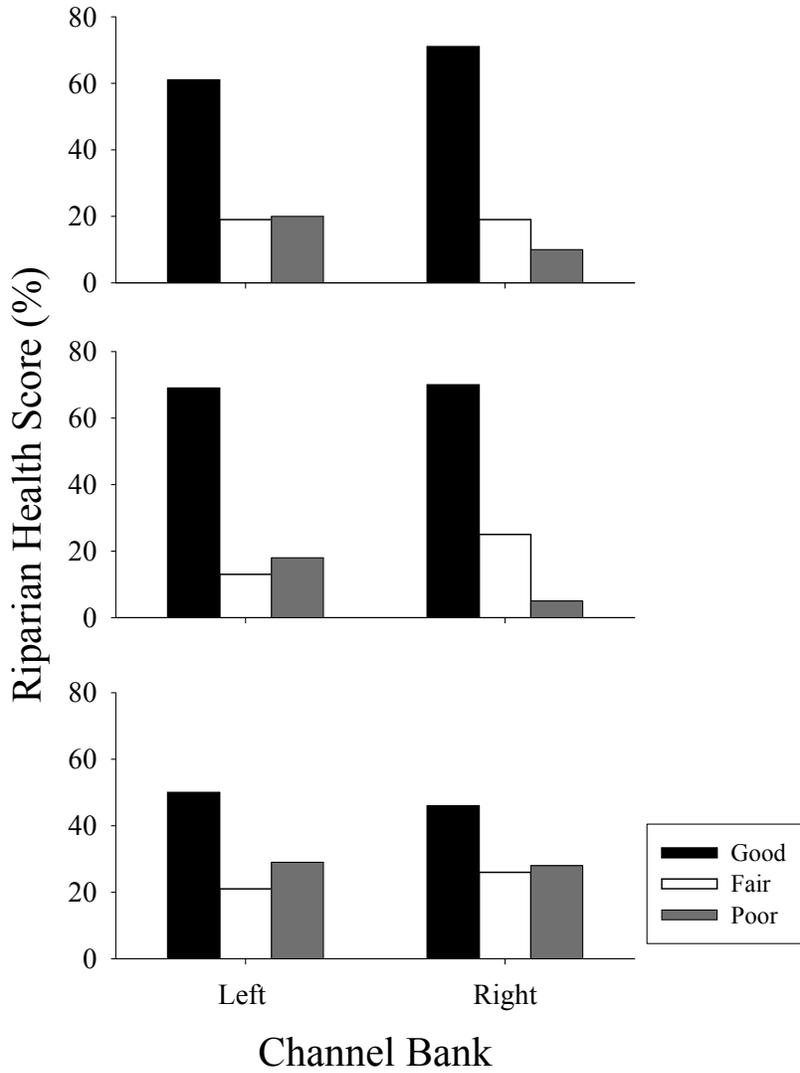
Figure 1. Riparian health scores for the Beaverlodge River drainage determined from aerial videography surveys.

In general, reaches assessed on the Beaverlodge drainage were in good condition; overall, 61% of reaches were rated as good, 21% as fair and 18% as poor (Figure 1). Note that we combined data from Windsor and Beavertail creeks because their health scores were almost identical. We found that health scores were usually similar when comparing left and right banks on stretches of river. We recorded the lowest health scores on Beavertail and Windsor creeks, and near Hythe on the Beaverlodge River. We will present the results of this project and the video to landowners to help promote discussion on riparian restoration and protection.

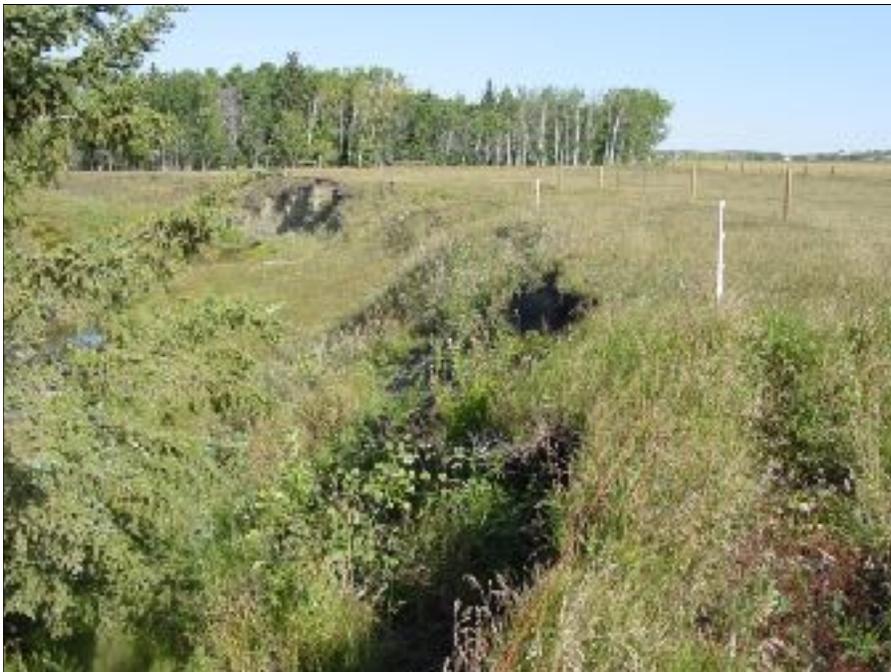
Degraded riparian area on the Hill site, with new riparian fencing. (Photo: J. Hallett)

In 2009, we completed two riparian fencing projects that totaled 1,666 m of fencing and protected 37.8 ha (93.5 ac). We also provided one off-site watering system to the Hill fencing project.

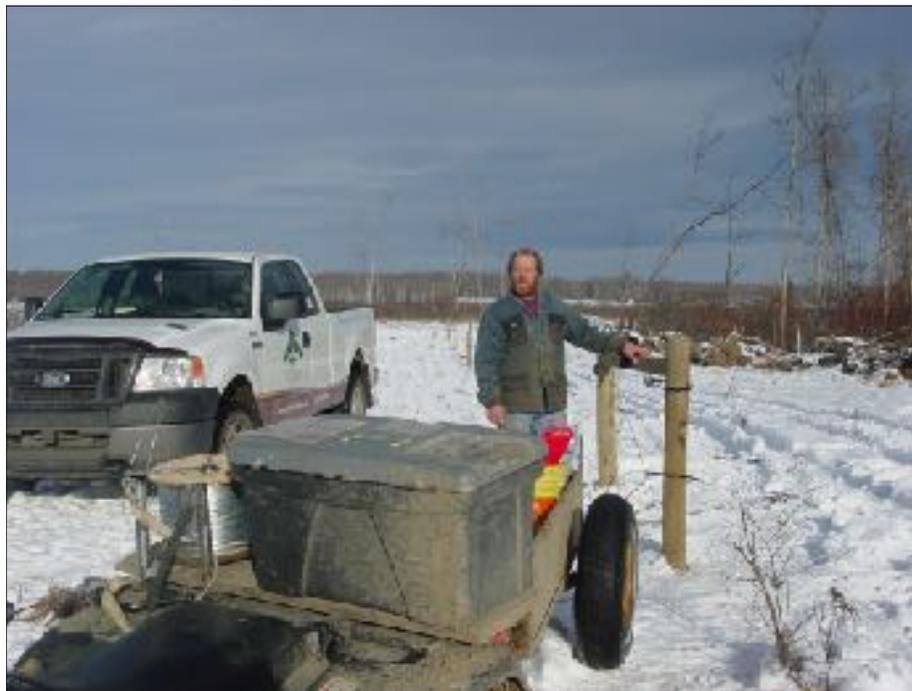
Local landowner Mr. Ammann erecting a riparian fence beside Steeprock Creek on his property with fencing materials supplied by ACA . (Photo: J. Hallett)
