Alberta Conservation Association 2010/11 Project Summary Report

Project Name: *Edson River Riparian Conservation*

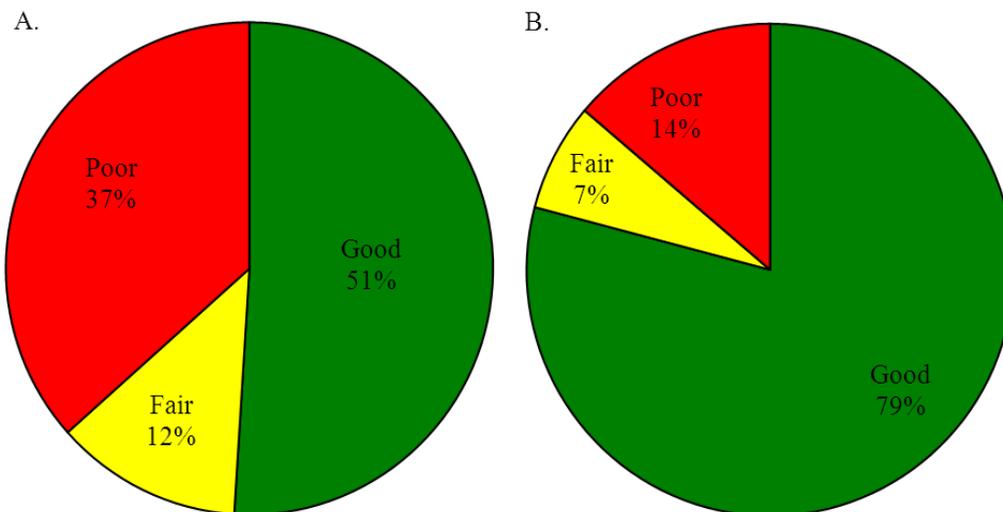
Almost half (49%) of the riparian areas associated with the mainstem Edson River were degraded, and the majority of the impacted sites were classified as having poor riparian health and integrity. The riparian health of the tributaries was considerably better than the mainstem, with only 21% of areas being noticeably degraded (Figure 1).

Figure 1. Edson River riparian health and integrity scores, 2010. Edson River mainstem is illustrated in “A”, six combined tributaries are illustrated in “B”.

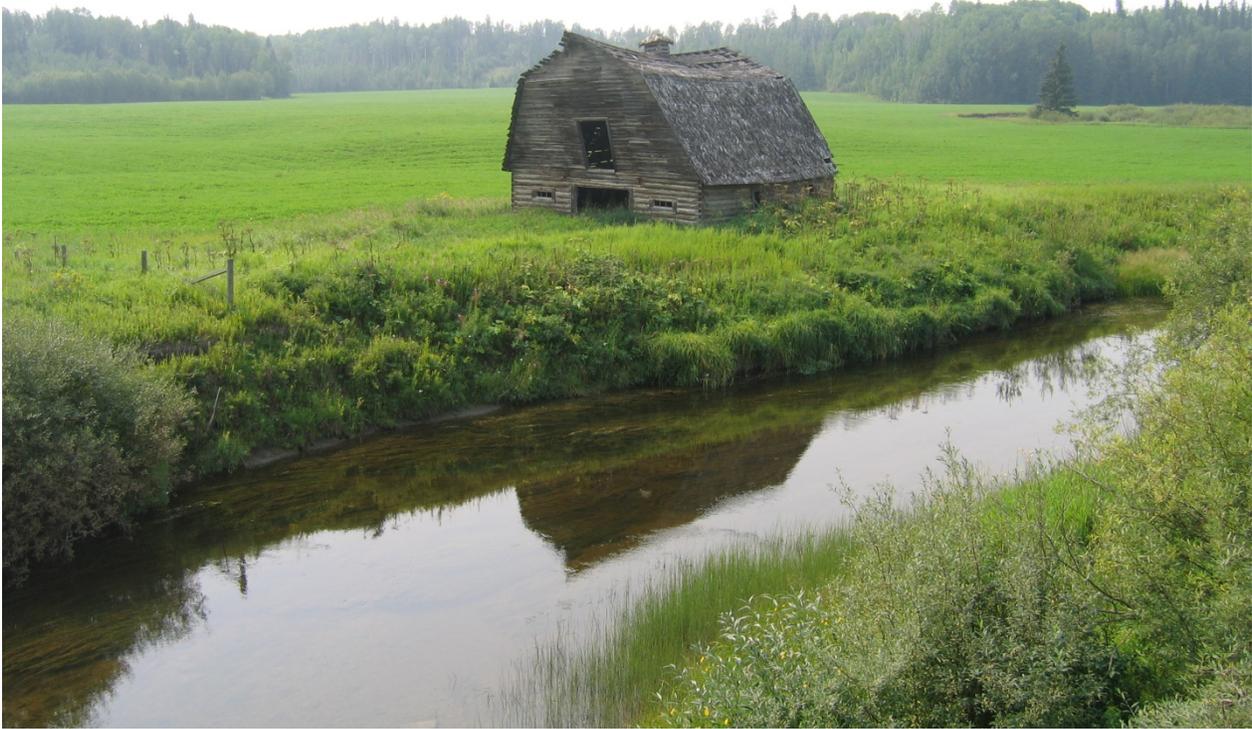
An abandoned barn indicating the long history of development and use of riparian areas along the Edson River. (Photo: Brendan Ganton)

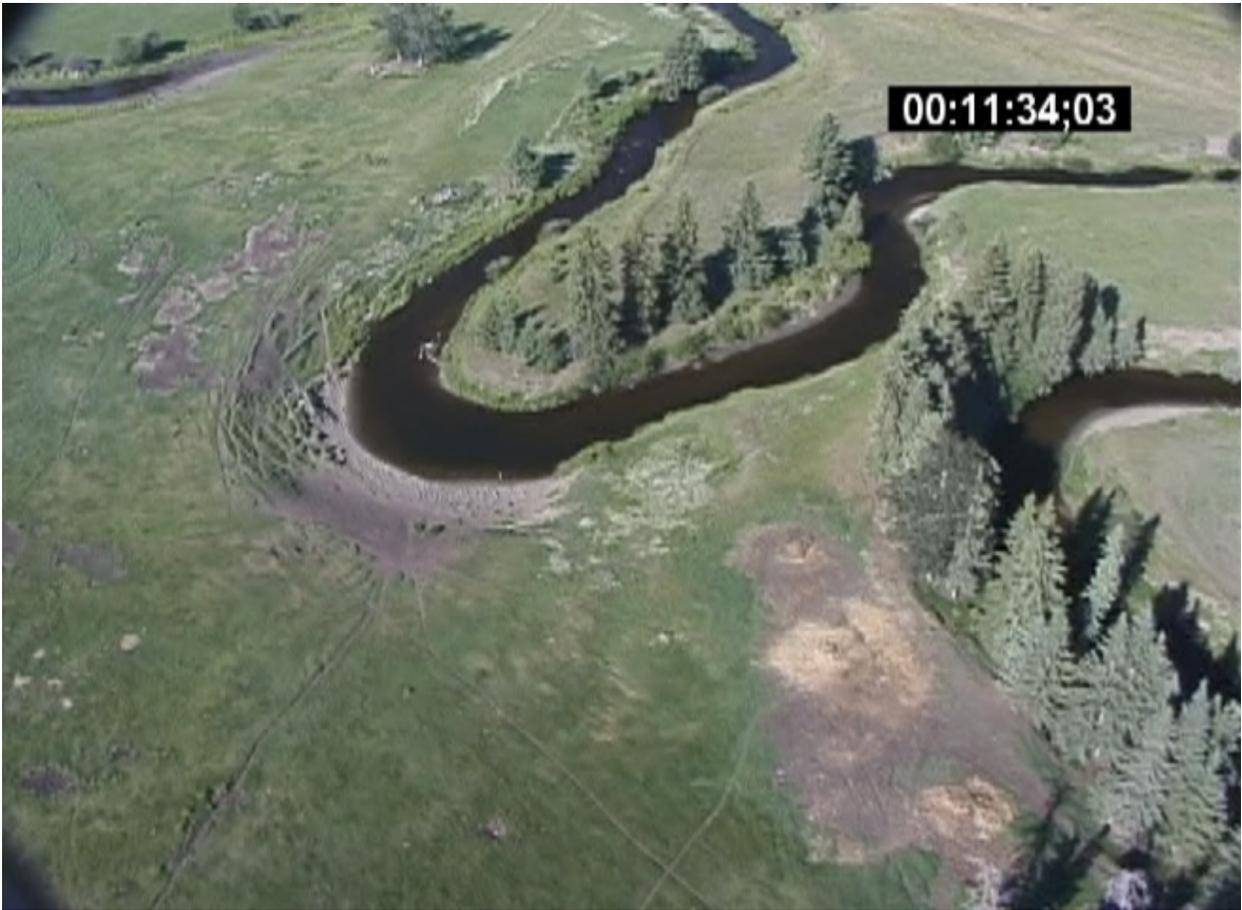
Sample image from videography showing severe degradation of streambanks related to intense grazing and watering of cattle in the river. (Photo: Walker Environmental)

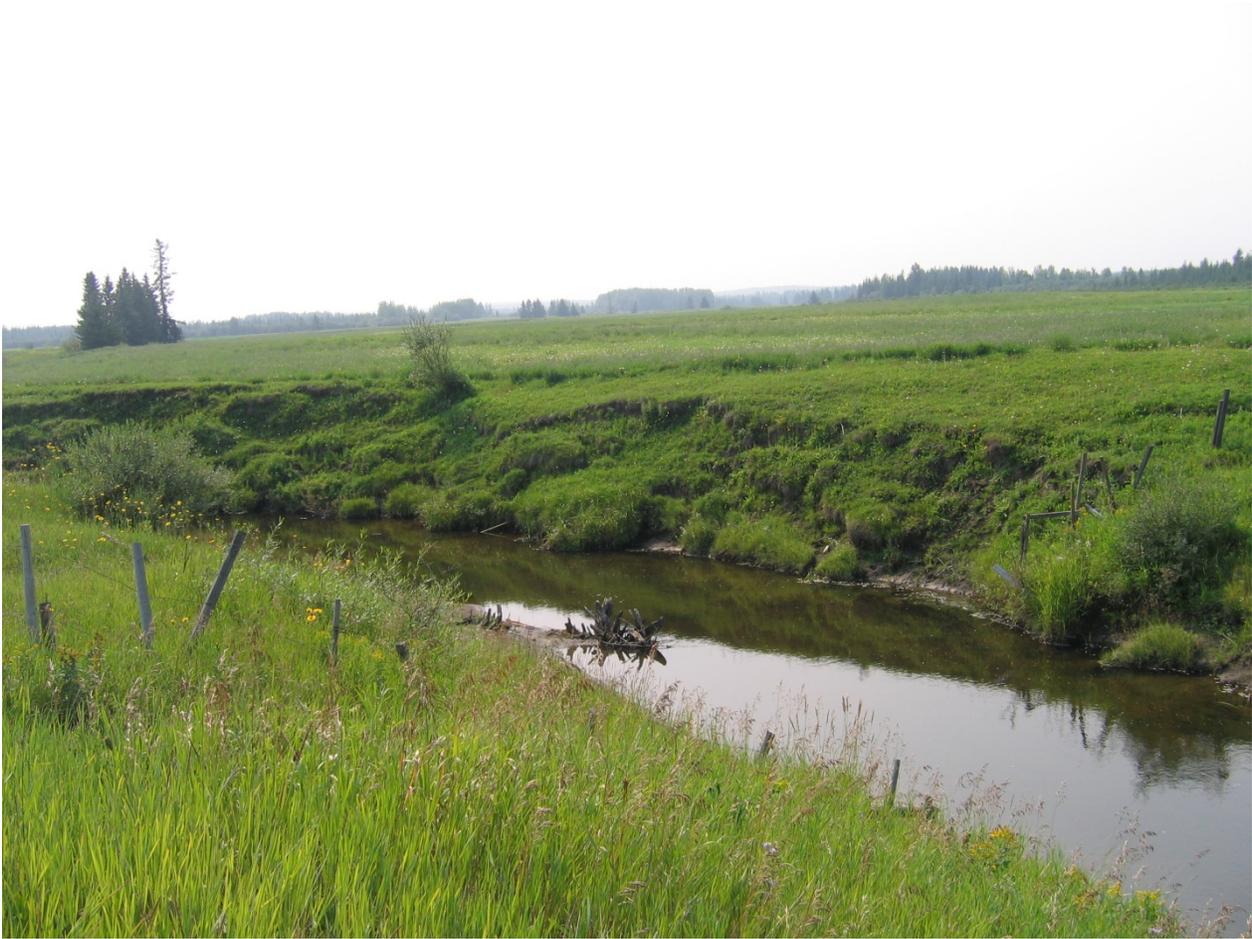
A potential riparian enhancement project site showing river bank instability and slumping caused by grazing, cultivation and removal of trees. (Photo: Brendan Ganton)

We identified 10 impacted sites for potential remediation. In 2011/12, we will meet on-site with landowners to solicit their participation in riparian enhancement projects.
