## **Alberta Conservation Association 2011/12 Project Summary Report**

**Project Name:** *Edson River Riparian Conservation*

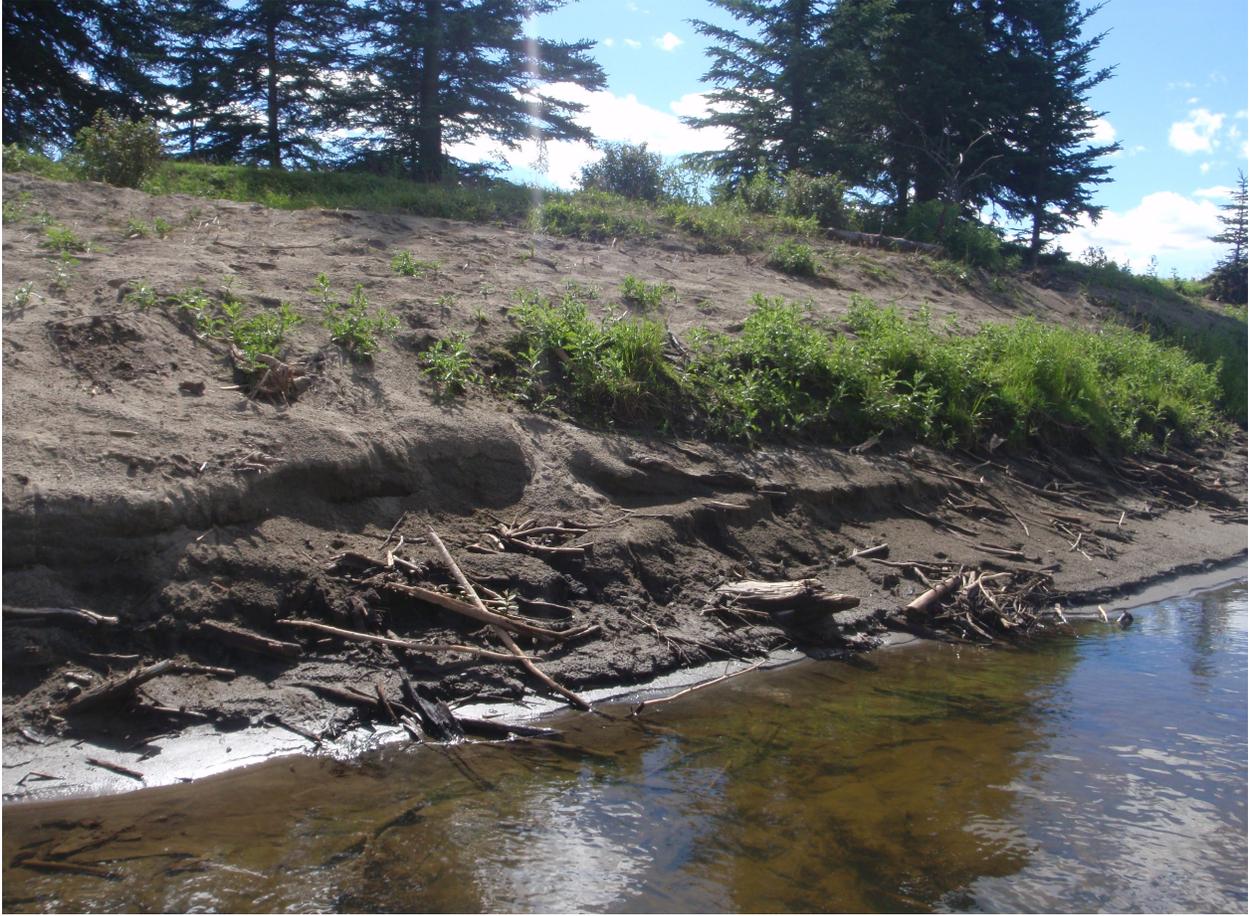
An eroded bank within a proposed riparian pasture showing bank slumping and invasive weeds, a product of livestock grazing. (Photo: Troy Furukawa)

In 2011/12, we worked with two landowners to plan and deliver riparian enhancements on their properties. In one case, we worked with a leaseholder to create a 30-m setback for haying near riparian areas, which will create a vegetated buffer between hayfields and the river. In a second case, we planned an exclusion fencing and off-site watering project that will immediately protect the riparian area from livestock damage. After several years of rest this excluded area will create a riparian pasture that will continue to protect the riparian area while allowing the landowner more options for livestock rotation and management. These two projects have the potential to improve more than 4 km of riparian habitat in three quarter sections, and will help encourage greater landowner participation in the upcoming years.

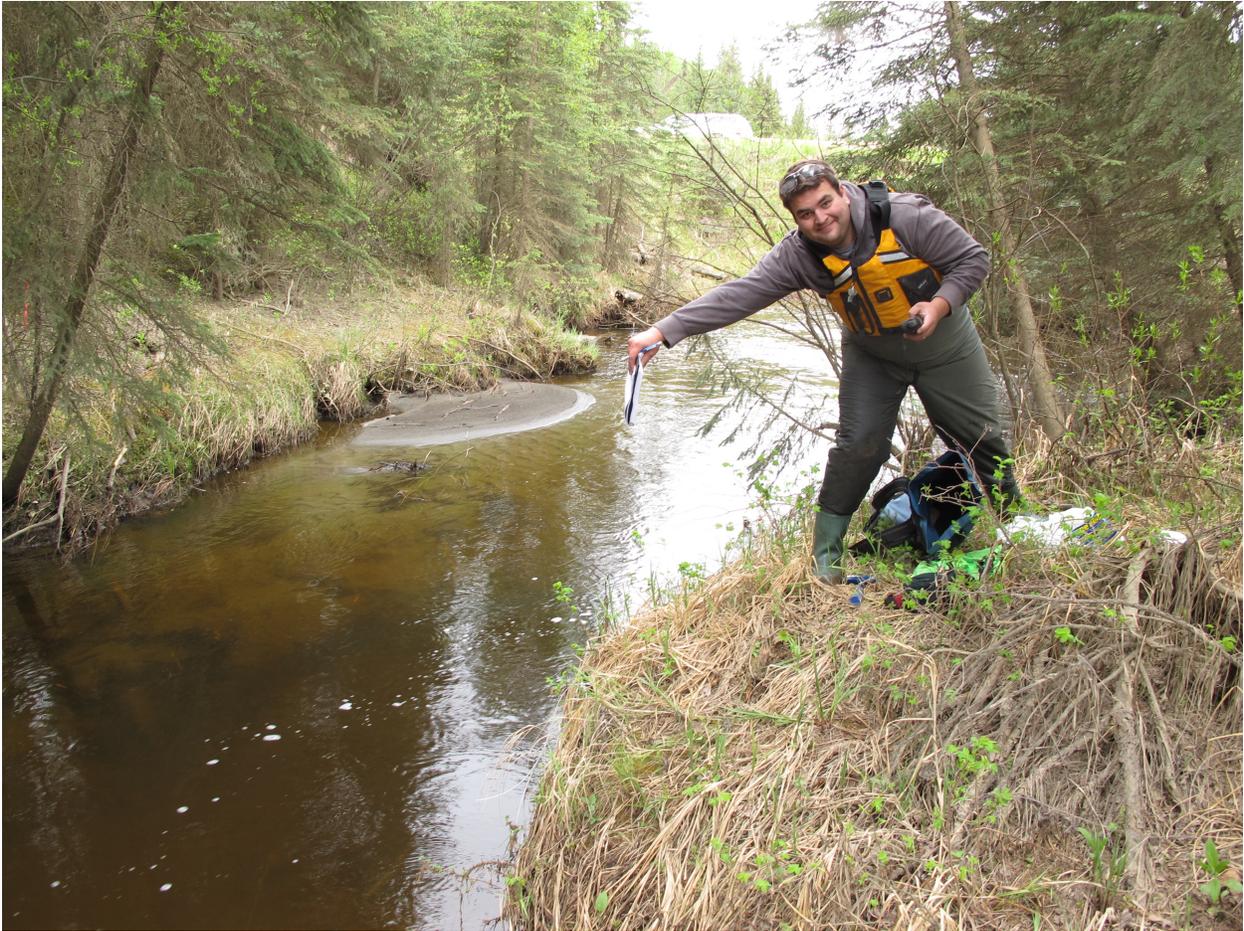
Alberta Conservation Association biologist, Brendan Ganton, indicates the location of an installed temperature monitoring device during collection of water quality samples, Edson River, Spring 2011. (Photo: Emily Turton)

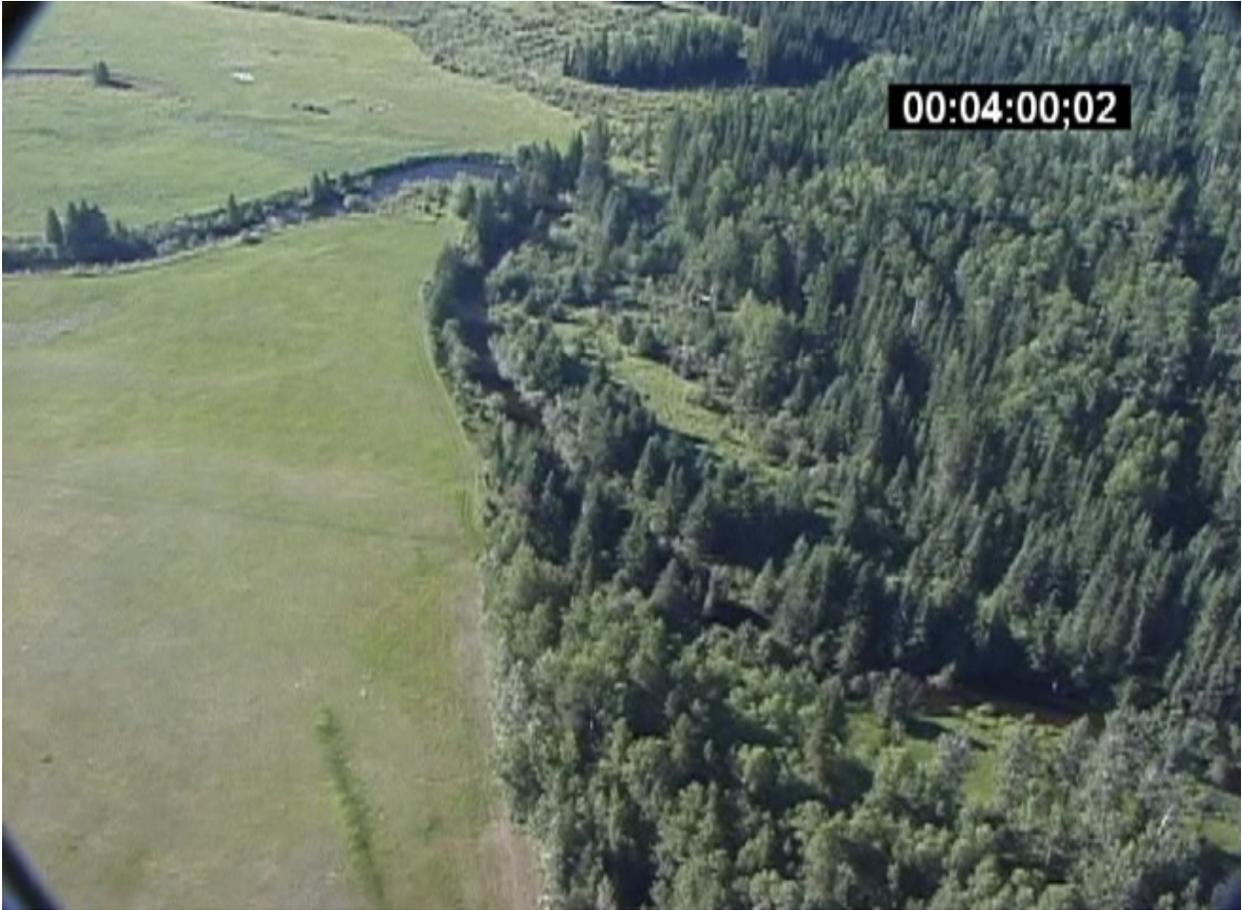
Aerial photo of the upper Edson River shows a contrast of relatively undisturbed, forested public land (right) to heavily impacted, cleared and grazed private lands (left). (Photo: Walker Environmental)
