## **Alberta Conservation Association 2016/17 Project Summary Report**

**Project Name:** Isle Lake Fisheries Restoration

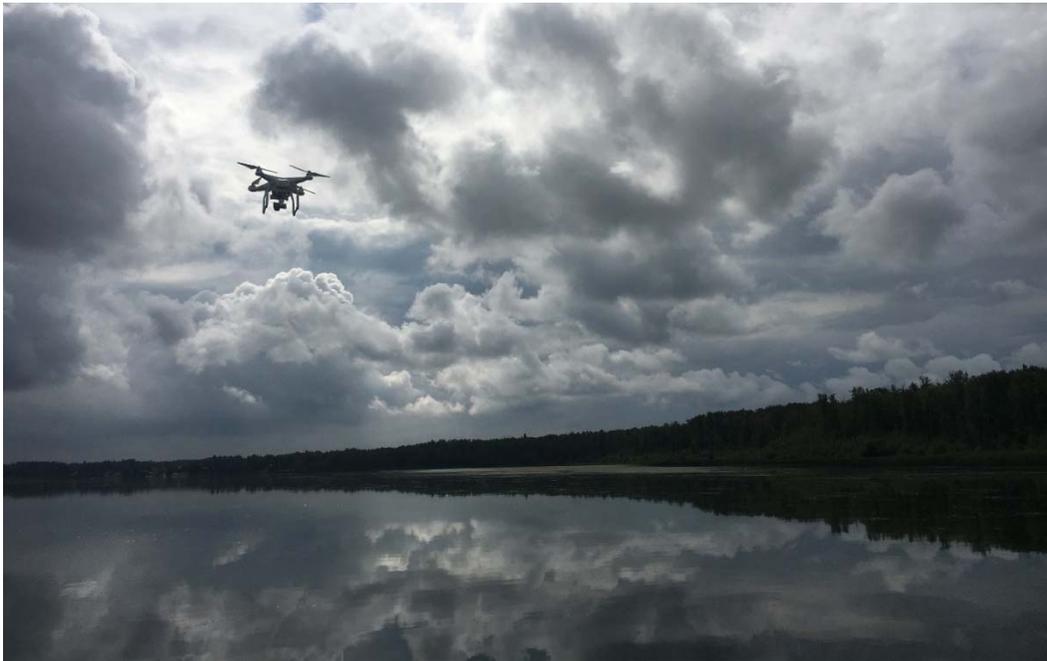
A drone returns to the boat after capturing video of the Isle Lake shoreline. Photo: Britt Schmidt

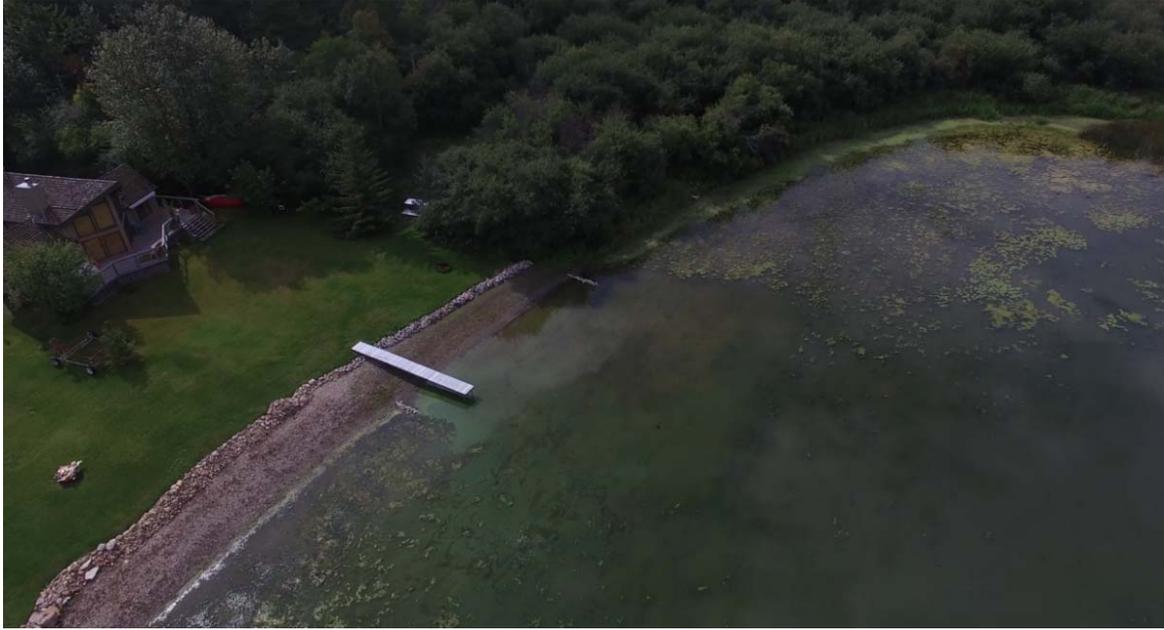
The transition from developed shoreline to a natural shoreline at Isle Lake. Greater numbers of rooted plants and shrubs can increase bank stability, reduce erosion, and filter water runoff to the lake. Photo: Brendan Ganton

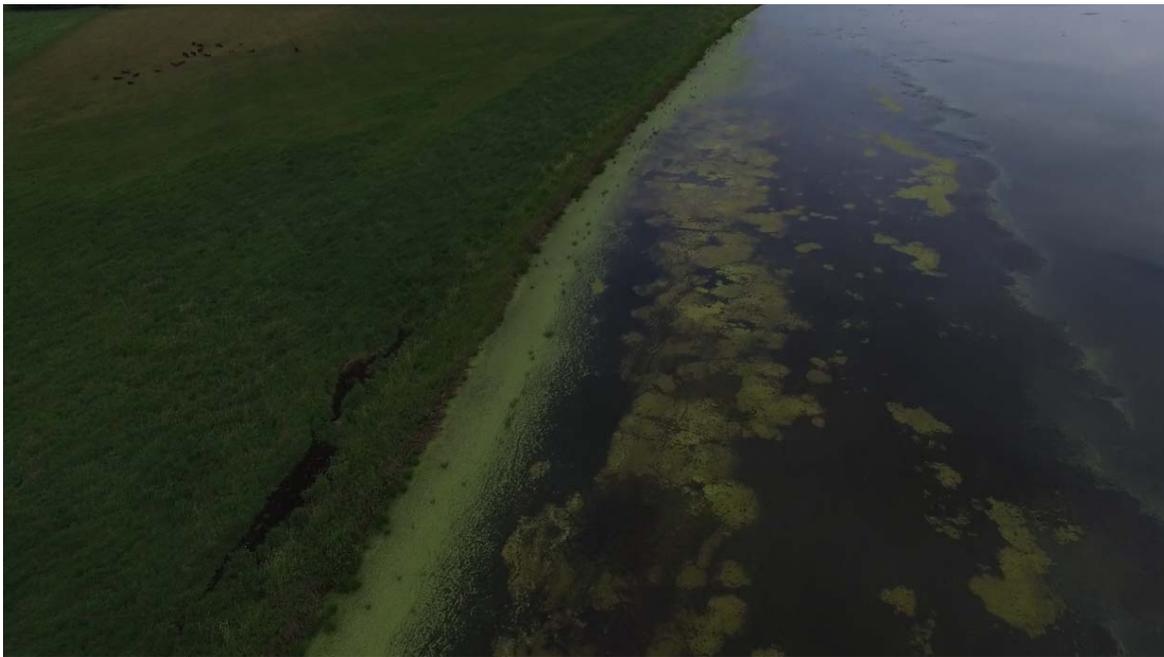
On parts of the shoreline of Isle Lake, free cattle access to the lake appears to have led to bank compression and collapse, formation of hummocks, and increased sediment and nutrient runoff to the lake. Photo: Brendan Ganton

Through our participation on the ALUS project advisory committee, we have been able to help guide the delivery of numerous on-the-ground projects throughout the Isle Lake basin. The projects delivered in 2016 focused primarily on cattle exclusion fencing and alternative watering systems. These projects have contributed to the rehabilitation of 160 acres of marginal agricultural land, allowing it to provide increased water filtration, nutrient uptake, habitat value and other ecological services while reducing erosion and flooding—all benefiting the Isle Lake basin. Of these projects, one was delivered with financial support from Alberta Conservation Association through administration of funding from the Environmental Damages Fund. This project involved installing 800 feet (244 m) of fence and a solar-powered watering system to prevent cattle from accessing a waterbody along the north shore of Isle Lake. Furthermore, by providing clean water in a trough, cattle loafing, bank erosion and nutrient runoff will be reduced at three other smaller waterbodies.
