Alberta Conservation Association 2013/14 Project Summary Report

Project Name: Edson River Riparian Conservation

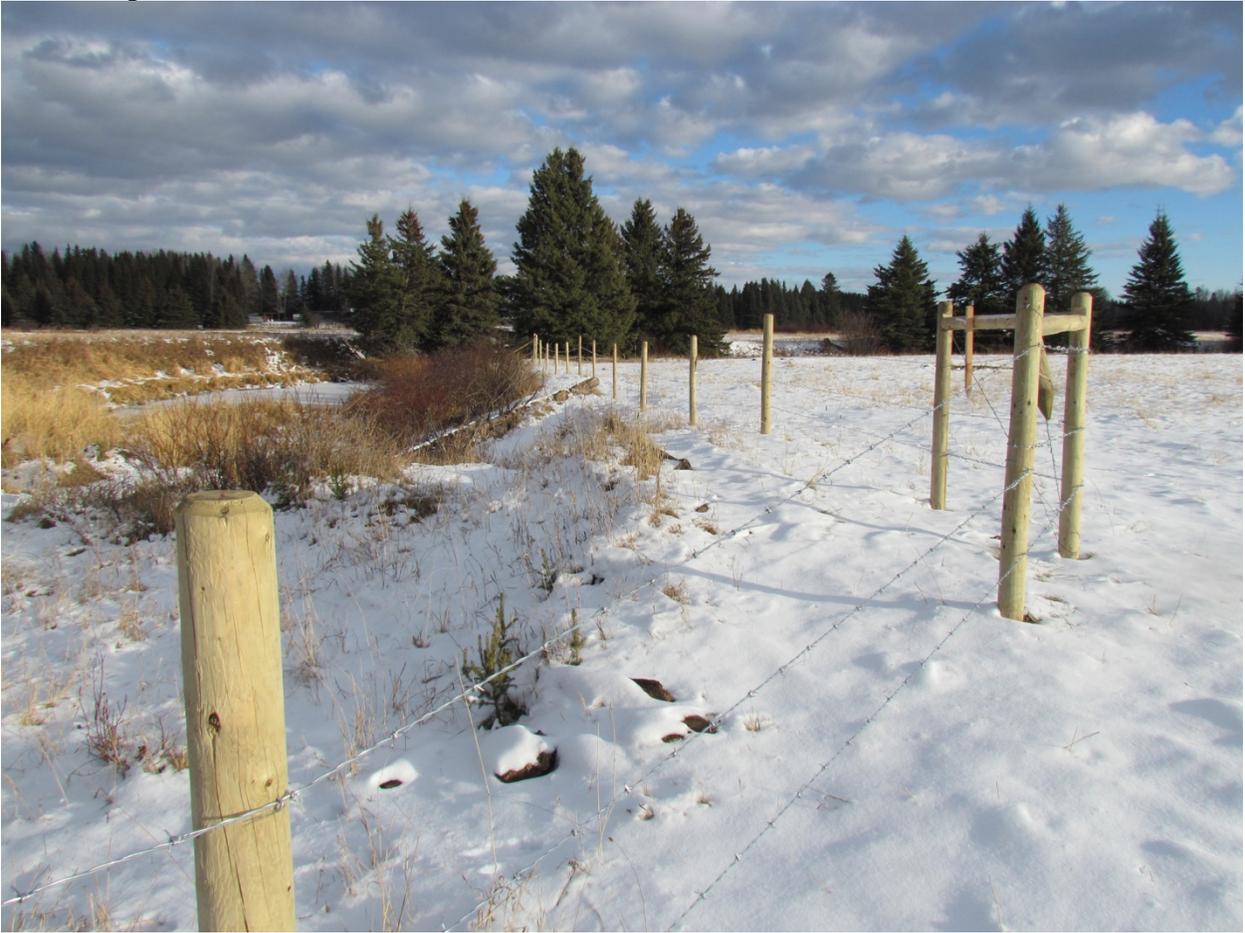
A portion of new wildlife-friendly livestock exclusion fence installed on the Edson River. Photo: Juanna Thompson
[Photo1_Riparian Edson_2013-14_Juanna Thompson.jpg]

In 2013/14, we partnered with one landowner to install over 1 km of wildlife-friendly exclusion fencing along the Edson River. In addition, we provided the same landowner with an off-site livestock watering system to prevent further riparian habitat degradation, which was also installed in 2013. We signed one Riparian Habitat Agreement with a landowner to exclude approximately six acres of riparian habitat from cattle grazing.

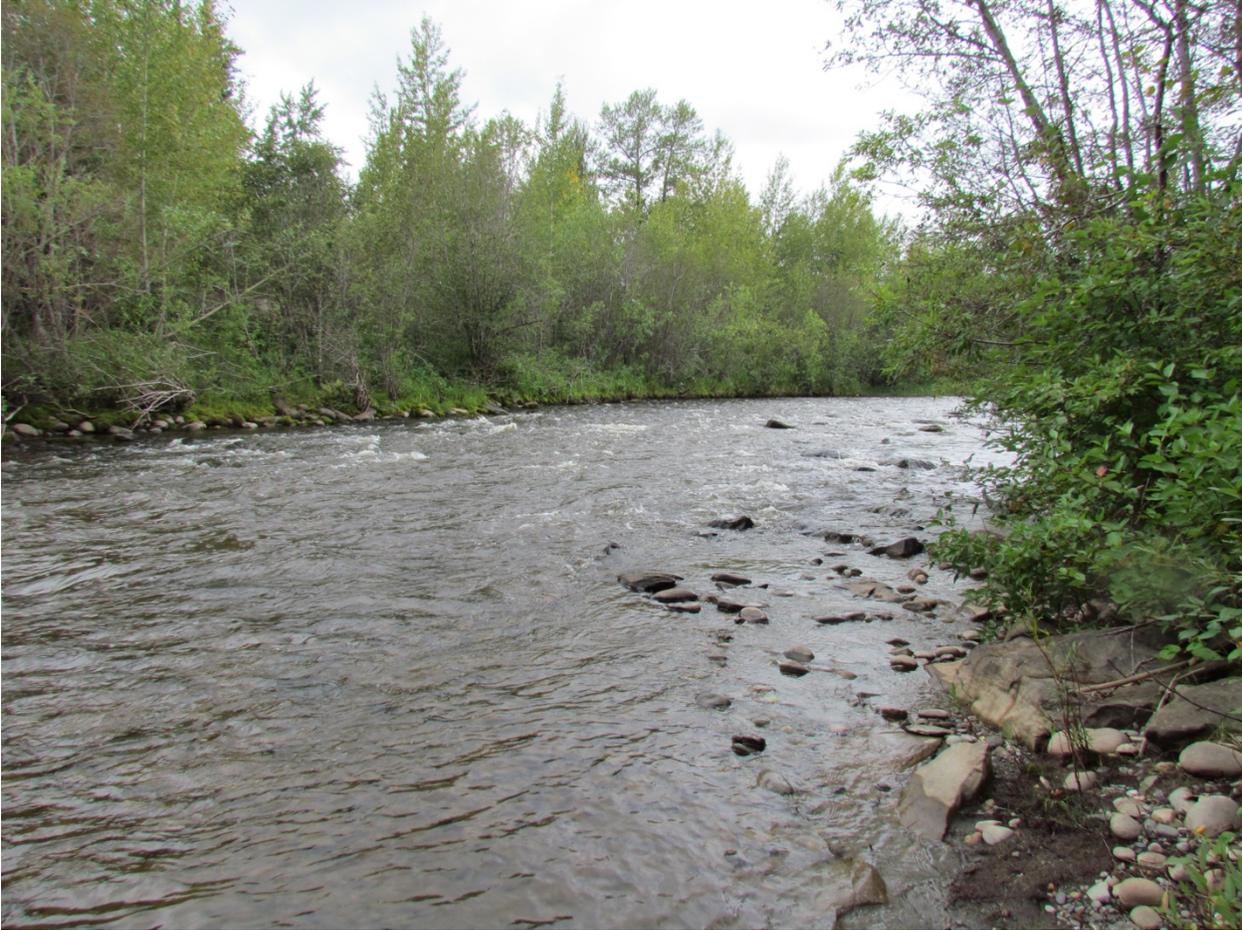
Water Sampling Station Number 1, looking downstream on the Edson River. Photo: Erin VanderMarel
[Photo2_Riparian Edson_2013-14_Erin VanderMarel.jpg]

As part of our long-term monitoring protocol, we conducted water quality analyses at five locations along the Edson River. Water quality “grab” samples were collected once in spring and once in fall, with the two grab samples from each site tested for nutrients, turbidity, chlorophyll-*a* and fecal coliforms. Samples were submitted to Maxxam Analytics in Edmonton for testing.

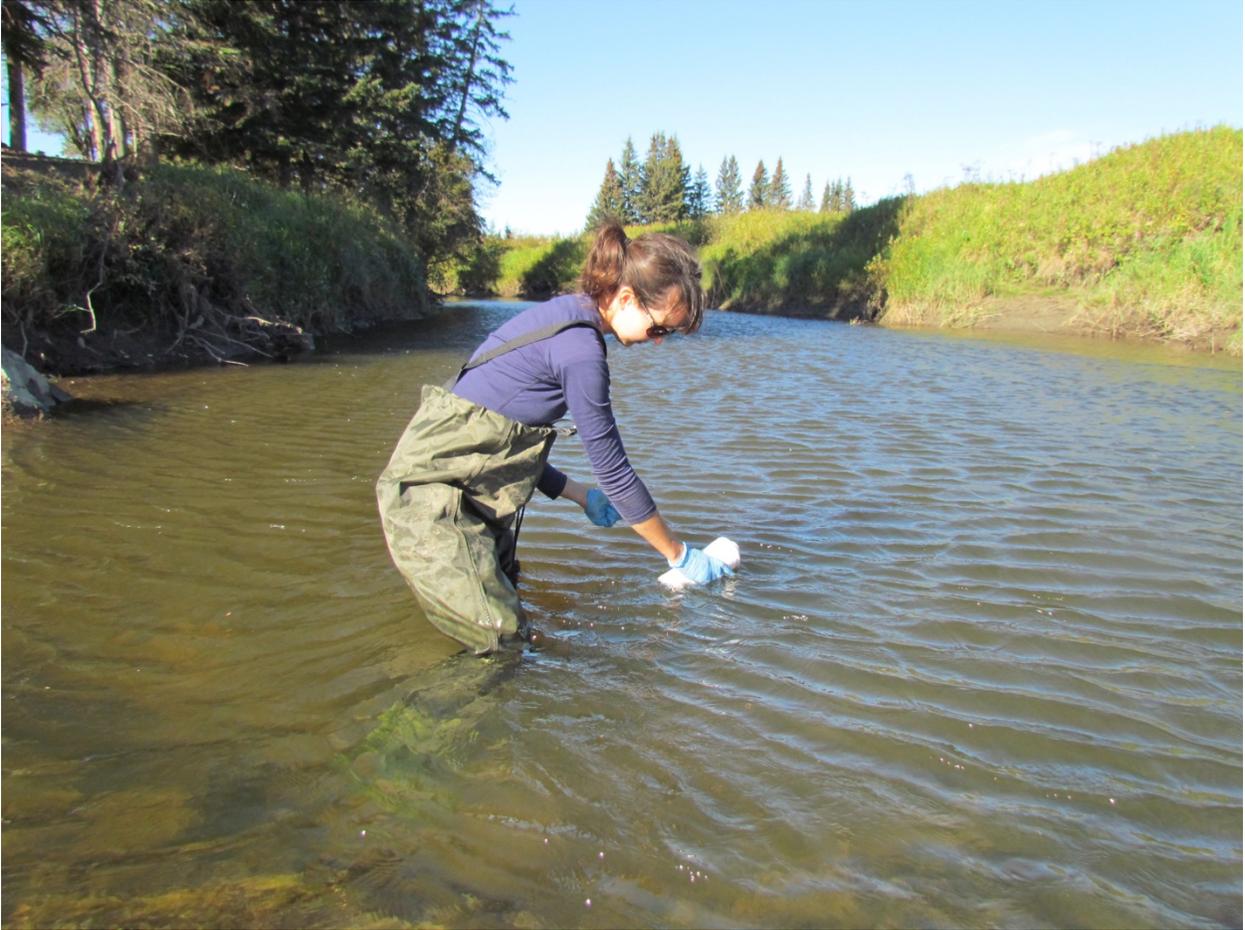
Alberta Conservation Association biologist Juanna Thompson conducting water quality sampling on the Edson River. Photo: Erin VanderMarel
[Photo3_Riparian Edson_2013-14_Erin VanderMarel.jpg]
