**Alberta Conservation Association
2009/10 Project Summary Report**

Project Name: *Lesser Slave Lake Riparian Conservation*

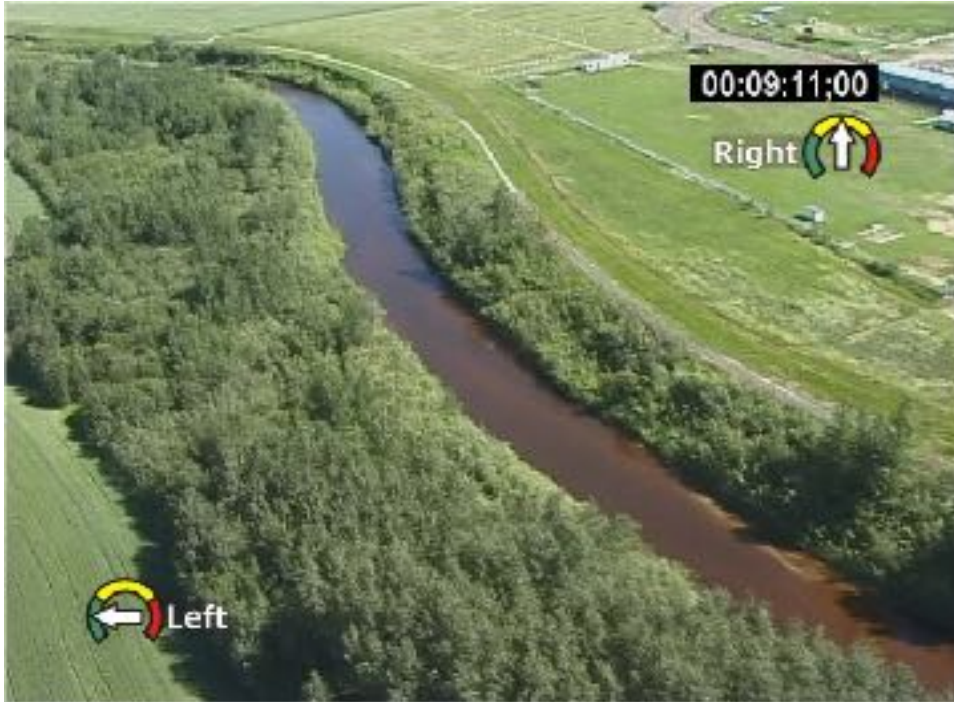
Aerial view of riparian areas along a reach of the West Prairie River. Arrows indicate riparian health condition: green = good, yellow = fair and red = poor. (Photo: George Walker, Walker Environmental)

In general, reaches assessed on the South Heart River were in good condition (62%). Scores were similar for both left and right banks. Riparian areas along the West Prairie were 43% good, 27% fair and 30% poor condition. The lowest health scores occurred along the channelized section of the river downstream of the town of High Prairie. Data collected as part of this project will be used to gain insight into the current state of the watershed. It will be available to landowners and land managers to raise awareness and discussion as to what steps should be taken to protect the 'healthy' areas and to restore the impaired areas.

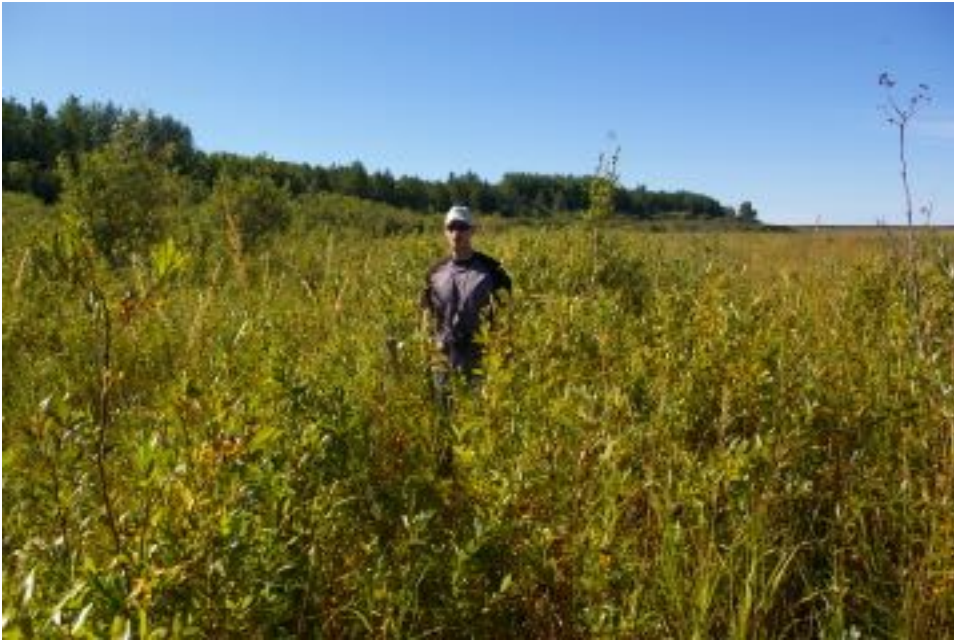
Willow growth along a riparian restoration project – Lesser Slave Lake. (Photo: Jon Van Dijk)
