**Alberta Conservation Association  
2009/10 Project Summary Report**

**Project Name:** *Summerkill Prevention Investigation in ACA Aerated Lakes*

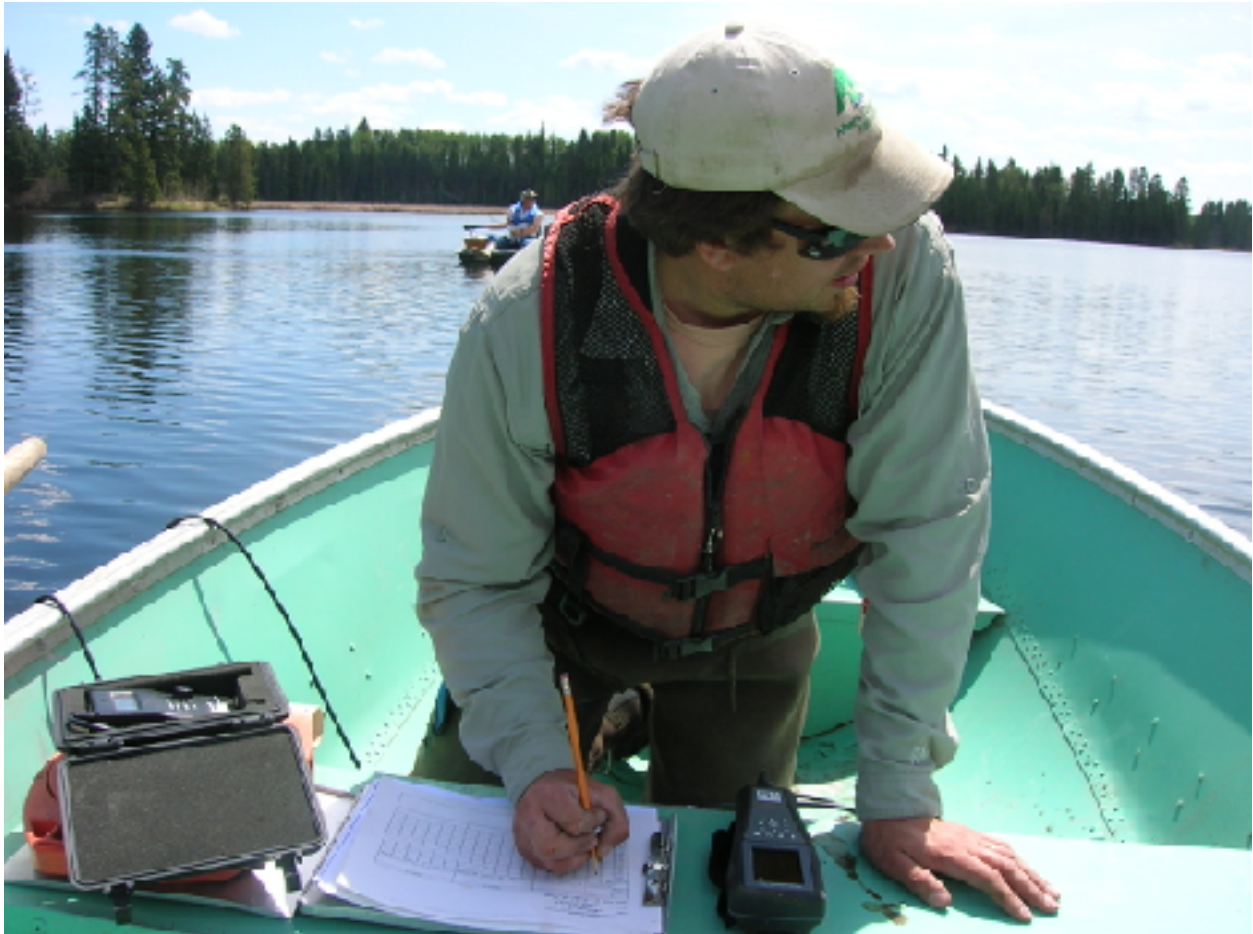
Alberta Conservation Association staff, Chad Judd recording water quality data from Beaver Lake. (Photo: Corey Rasmussen)

We collected temperature and oxygen profiles at 1.0-m intervals from the lake surface to the lake bottom at a minimum of three sampling stations in each of the following five lakes: Beaver, Dipping Vat, Fiesta, Figure Eight and Swan lakes. Sampling occurred weekly in July and August and bi-weekly in May, June and September. We measured temperature, DO, pH and conductivity profiles in situ with a hand-held YSI unit (model E528 Pro Series plus). We also collected monthly integrated water samples from each waterbody and had these analysed for concentrations of total phosphorus, total nitrogen, chlorophyll-a, nitrite and nitrate by a CAEAL accredited laboratory (Canadian Association for Environmental Analytical Laboratories). We present DO and temperature data only in this summary.

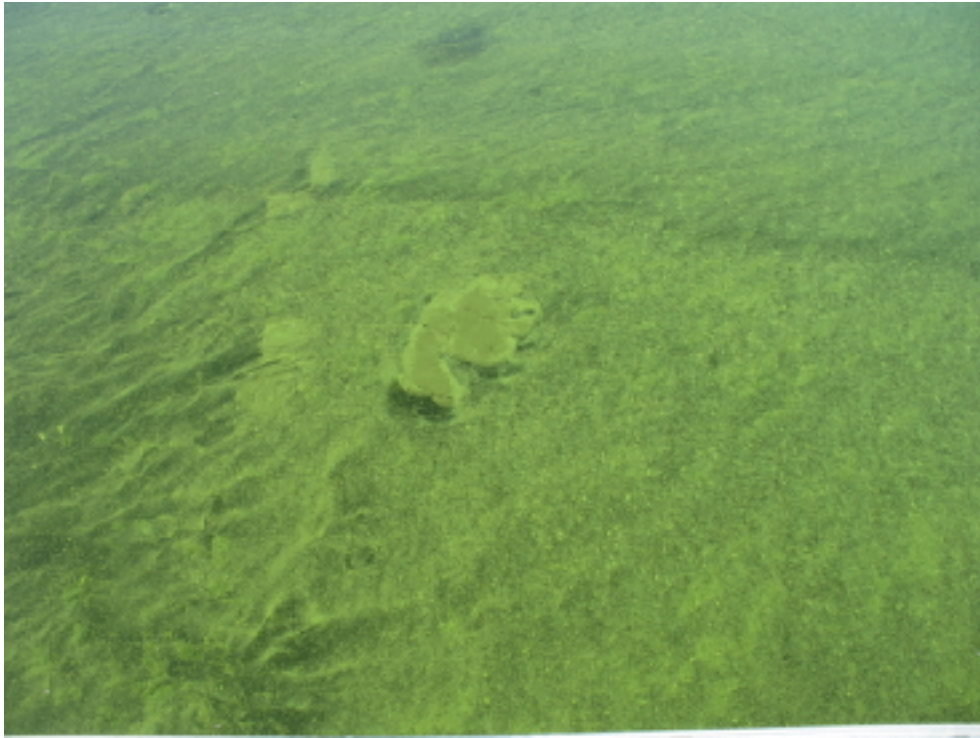
Algae bloom in Swan Lake during August 2009. (Photo: Dave Jackson)

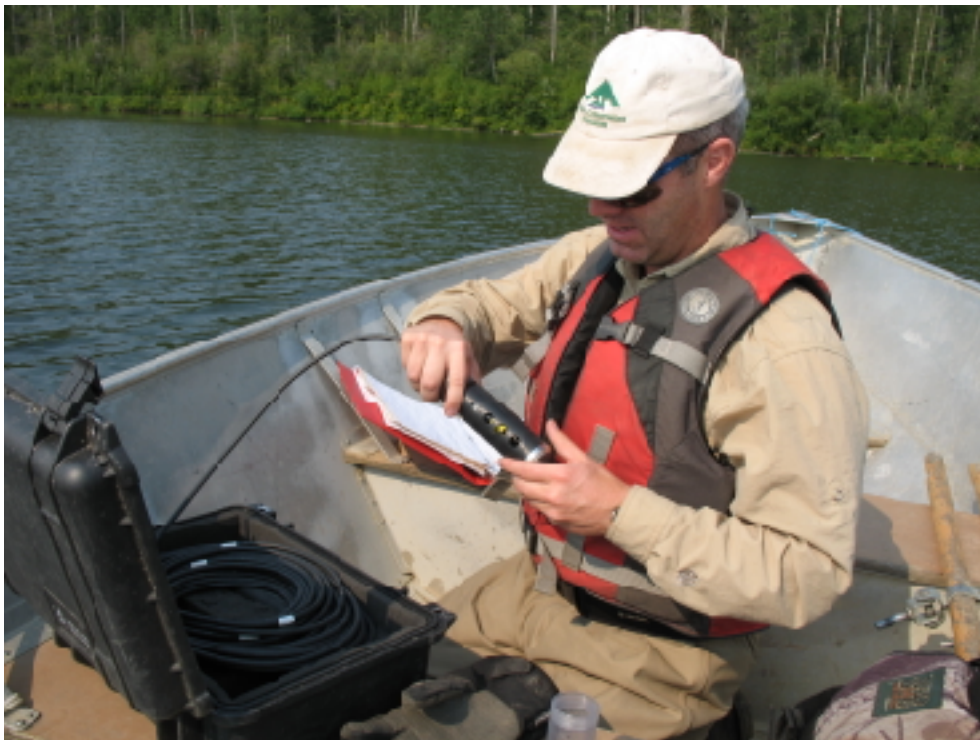
Water quality sampling with YSI unit in Swan Lake. (Photo: Paul Hvenegaard)
