Alberta Conservation Association 2017/18 Project Summary Report

Project Name: New Lake Aeration Development

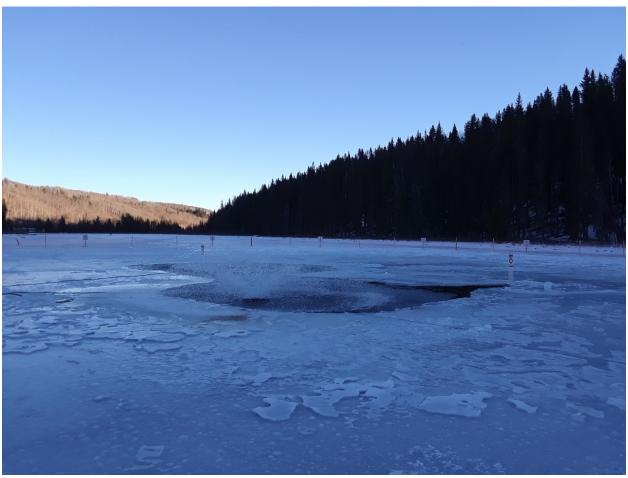
Fountain action of the surface aerators shortly after being powered on for the first time at Winchell Lake. Photo: Andrew Clough

Power facility installation at Winchell Lake was completed in early December 2017 and aeration was immediately commenced. Oxygen levels remained adequate throughout the winter season and were consistently higher than previous unaerated seasons (Table 1).

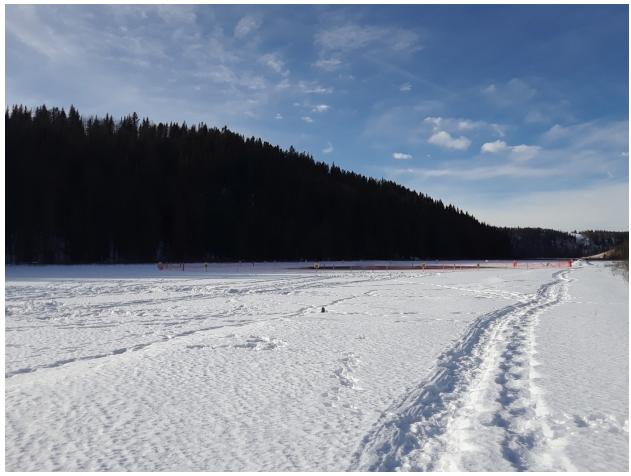
Safety fence and warning signage surrounding surface aerator in Late January 2018 at Winchell Lake. Photo: Andrew Clough
