**Alberta Conservation Association
2023/24 Project Summary Report**

Project Name: West-Central Culvert Remediation

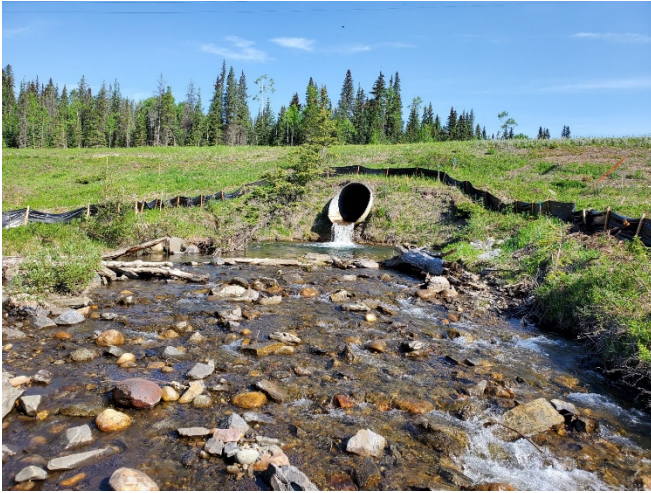
Photo 1. A barrier to upstream fish movement that is being remediated. Photo: Chad Judd.

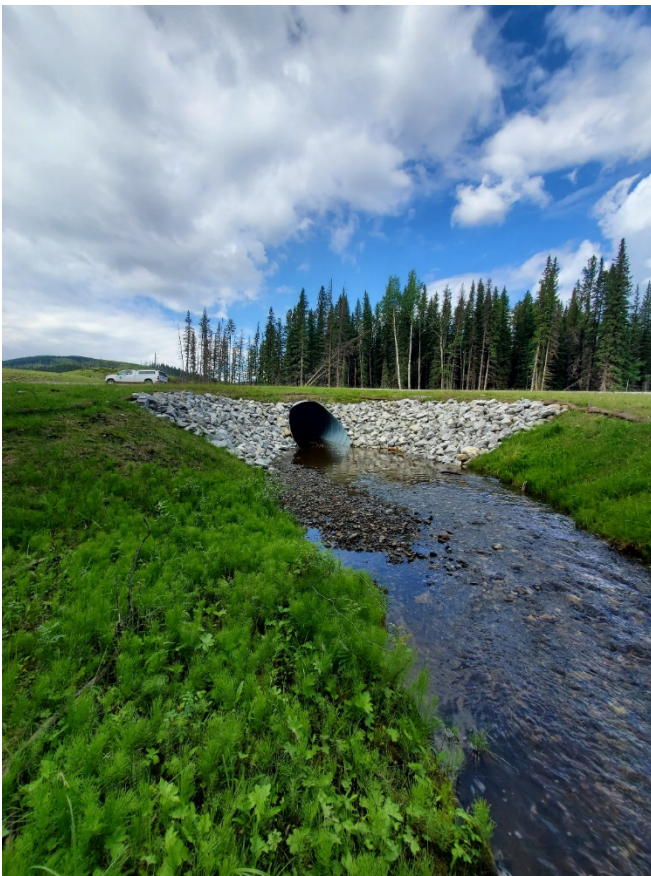
Photo 2. A recently remediated crossing that was assessed in 2023. Photo: Chad Judd

We captured 505 fish from six different species with brook trout being the most abundant species comprising 67% of our catch. Fish were found above each remediated crossing except one, and each remediated crossing had either submerged or embedded outlets allowing for fish to enter the culverts. The remediated crossings provided fish with similar habitat qualities including conductivity, dissolved oxygen, temperature, and turbidity upstream and downstream of the crossings. The newly or soon to be reconnected watersheds above the Gonika, Logan, McCue, and Stud creeks crossings contained habitat that was cold and complex with gravel and cobble substrate, woody debris, and sections of undercut banks; qualities preferred by native trout. We will continue to document the fish community in these watersheds as they are reconnected to downstream habitats.
