**Alberta Conservation Association  
2008/09 Project Summary Report**

**Project name:** *A Preliminary Investigation of Crossings Structures in the Driftwood River Drainage Basin, Slave Lake, AB*

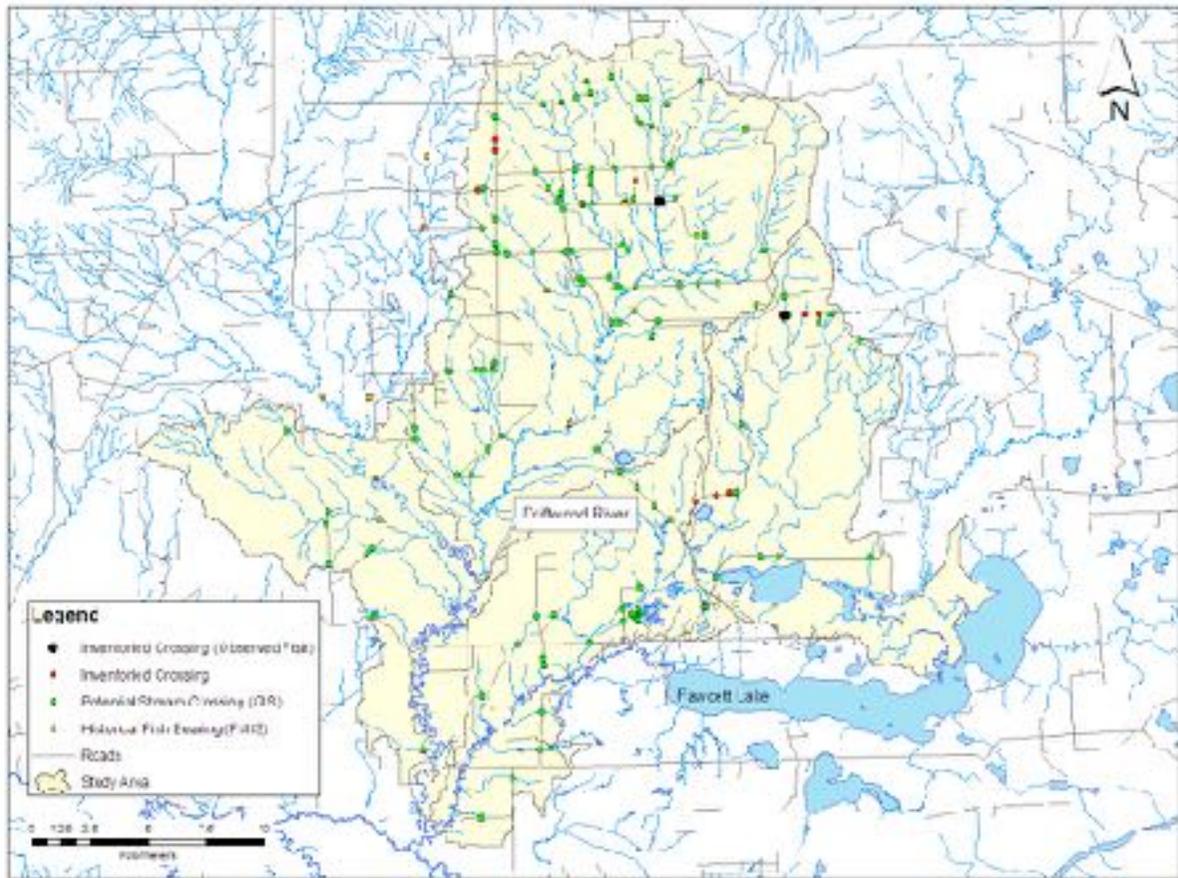
**Figure 1. Stream crossing inspected in a sub-basin of the Driftwood River, north of Fawcett Lake, Alberta, 2008**

debris blocking > 10% of the area of the passage. Blockages were a result of woody debris and collapsing culverts. Seven crossings had both a significant outfall drop height and the passage blocked by debris. Fifteen of the 29 crossings showed evidence of bank erosion and sedimentation of the adjacent watercourse. In total, 18 of the 29 crossings (i.e., 62%) could benefit from remedial measures. However, we identified only two sites as being fish-bearing; the species of fish at these locations are unknown. Importantly, both of the fish-bearing stream crossings had an outfall drop that may impede fish movements.

In total, 18 of the 29 crossings (i.e., 62%) could benefit from remedial measures such as sediment control or replacement of culvert. High priority areas include the seven crossings that had both an outfall drop height > 10 cm and > 10% of the passage blocked by debris. Further, stream connectivity should be restored at the two fish-bearing locations that had an outfall drop
