The Sturgeon River Riparian Health Assessment Report, 2001

James Milner Biotechnician

Alberta Conservation Association Northern East Slopes Region Edson

January, 2002

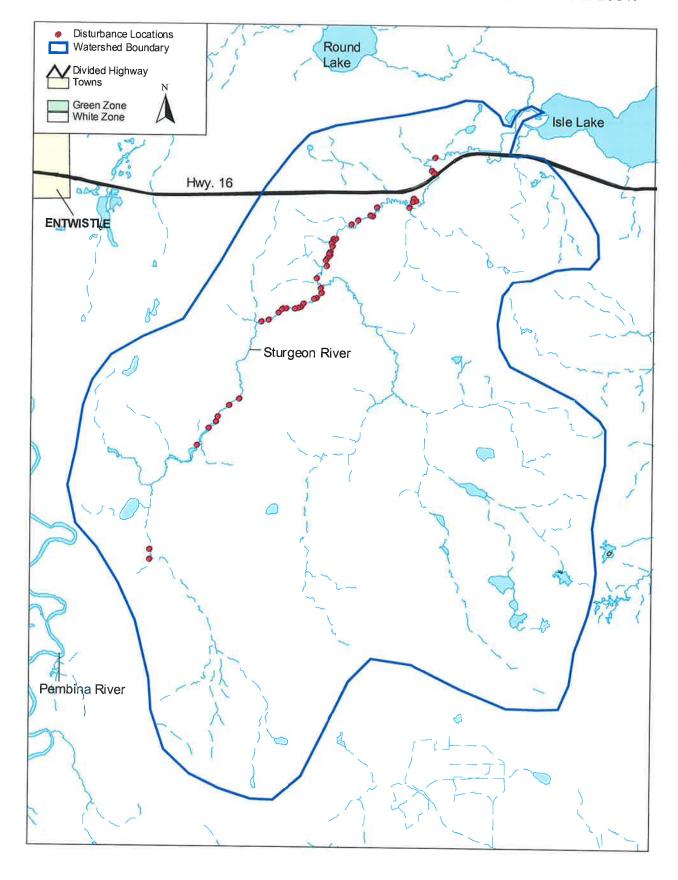
Map of the Sturgeon River Watershed with Disturbance Sites found in 2001

Appendix 3. Map of the Sturgeon River watershed with disturbance sites found in 2001.

The number of disturbance sites found in a particular quarter section will help determine the priority level for future streambank fencing projects. All disturbance sites identified in 2001 are displayed in Appendix 3 as well as on the Indian Resource Satellite (I.R.S.) imagery section maps in Appendix 4. The overall health of the riparian area on the Sturgeon River will most likely decrease due to the amount of agricultural activity along the river unless action is taken to control the degradation of the affected areas.
